## North Tahoe and Meeks Bay Fire Protection Districts

### **Chief's Corner: Sierra Sun and Bonanza Too much snow can destroy your home.**

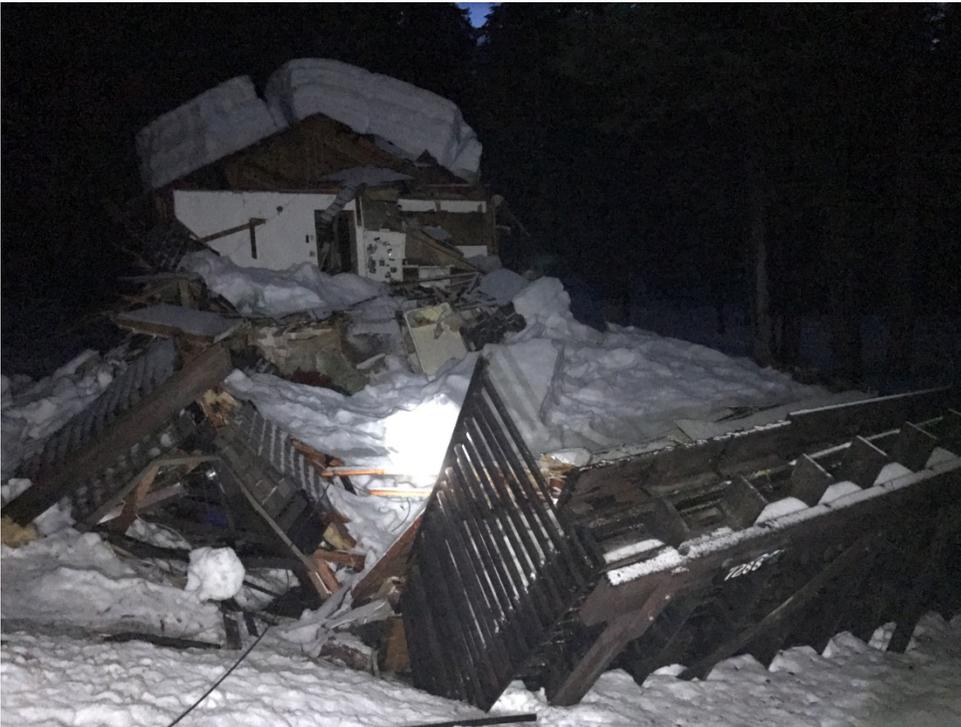
3/21/17 House collapse in Tahoma. The deck fell away from the house and took half the house with it. House was unoccupied, no injuries. House had been unattended all winter. Meeks Bay Fire Protection District and North Tahoe Fire Protection District Responded
